Knoydart Estate– Peatland Restoration Phase 1

Typical Site Conditions and Treatments

Prepared for
Knoydart Estate / The Knoydart Foundations

Prepared by
Zulu Ecosystems

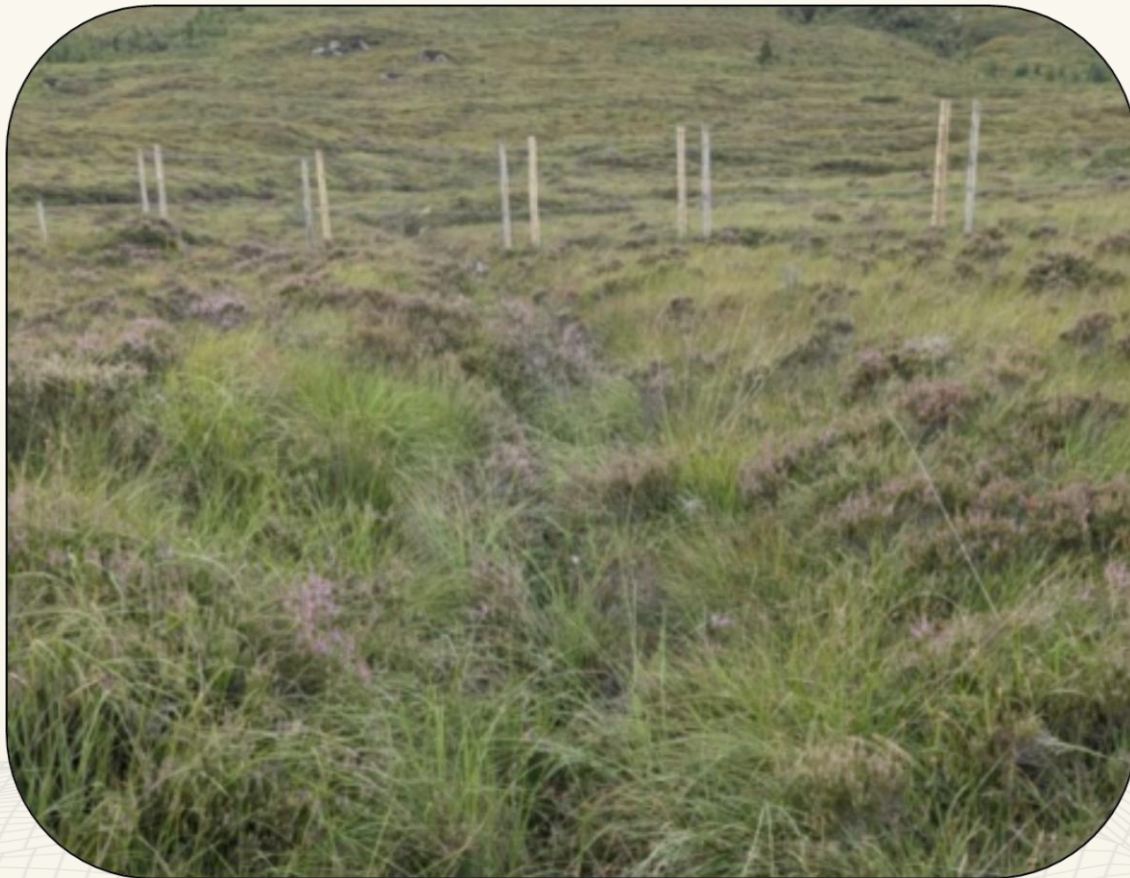
Man made drainage

Phase 1 focuses on areas of peatland degraded by man-made drainage, This is sometimes hidden beneath more developed Heath vegetation and deep Molinia but is still functional, creating a draw-down and drain-shadow effect. Block and re-profile these to restore natural flow paths.

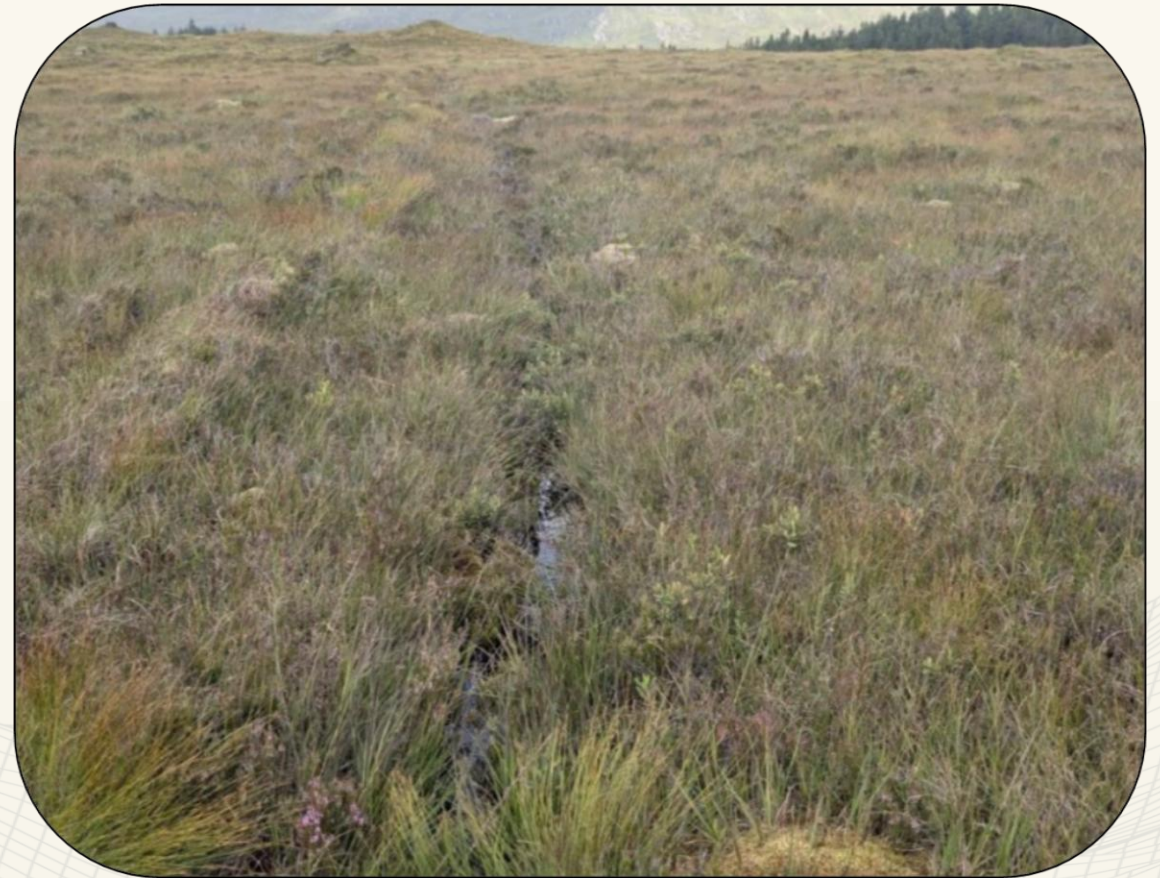
Drainage with raised spoil lines

A pronounced spoil ridge is still evident next to some drainage features. These drains are often still active and post blocking and re-profiling it will be important to ensure the spoil lines are lowered to allow natural overland flow.

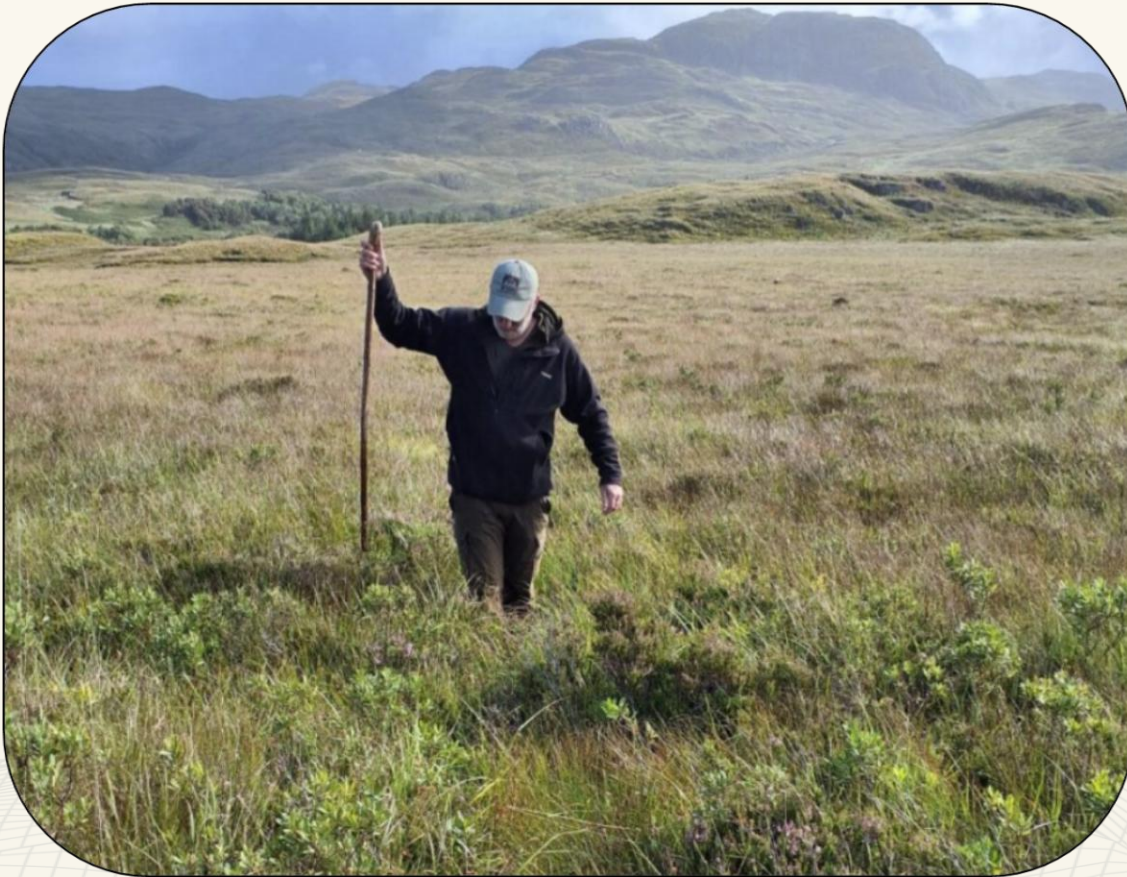
Drainage hidden beneath well-developed vegetation and deep Molinia but still functional. Drain void located by a Knoydart Foundation staff member who is knee deep in a drain channel.

Knoydart foundation staff member knee deep in a drain

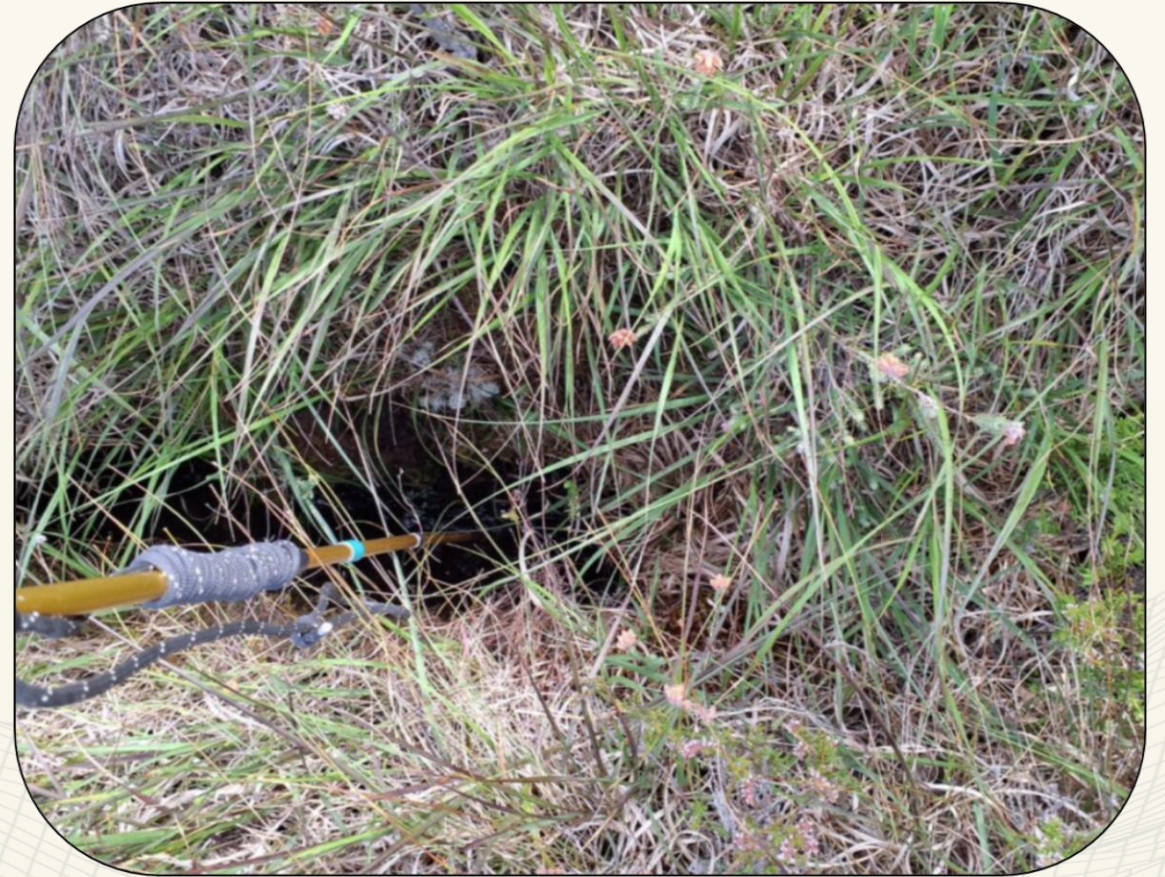
Collapsed drain shoulders

Some of the drain function is obscured due to the drain shoulders collapsing over the main void. This bell profile is quite common in peatland drainage and beneath the surface the drain channels are deep and active.

Bell profile drain void hiding a drain c.80cm deep and fast flowing

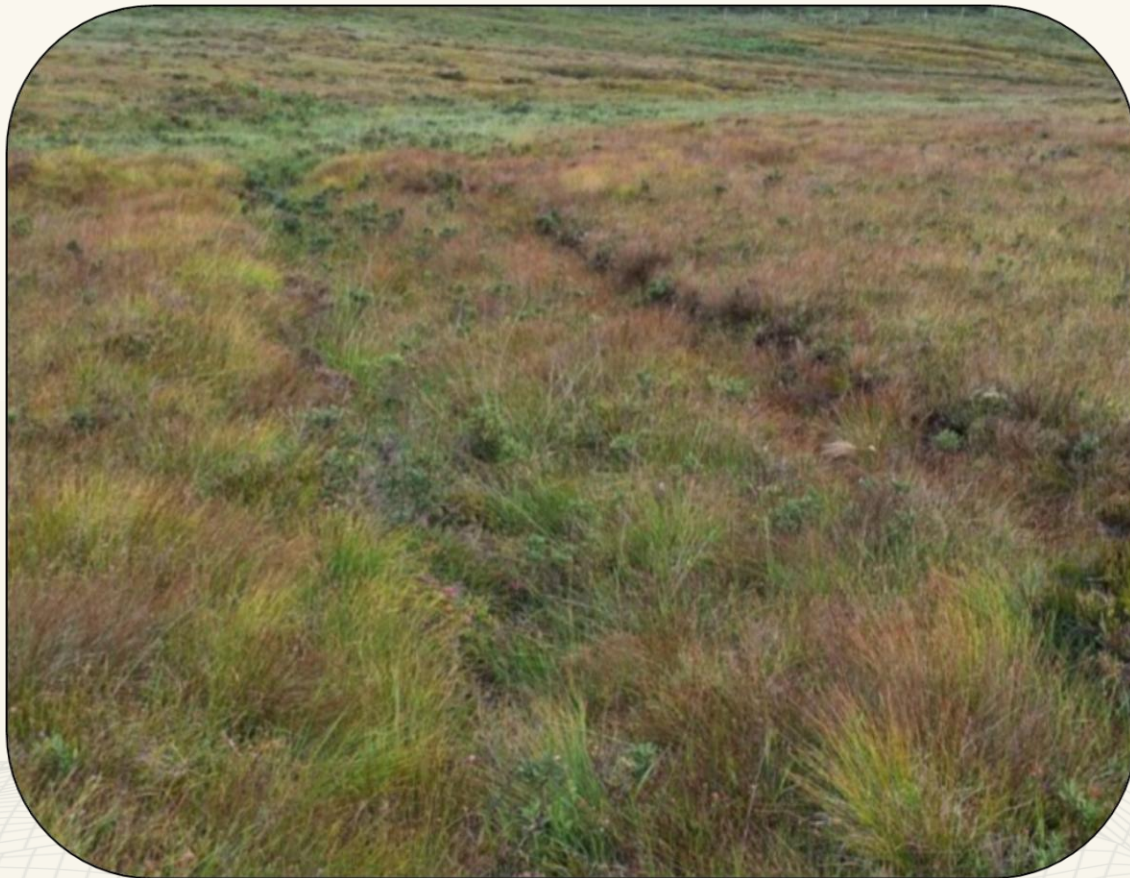
Cut banks, beds and drainage

Old cutting sites with metres of peat removed and relic cutting banks are abundant across the site. In some cases, these leave actively eroding peat edges, like hags, with adjacent peat de-watered by the drainage effect. There is also a lowered water table zone adjacent.

Reprofile bare edges, add oblique/cell bunds adjacent to raise water table

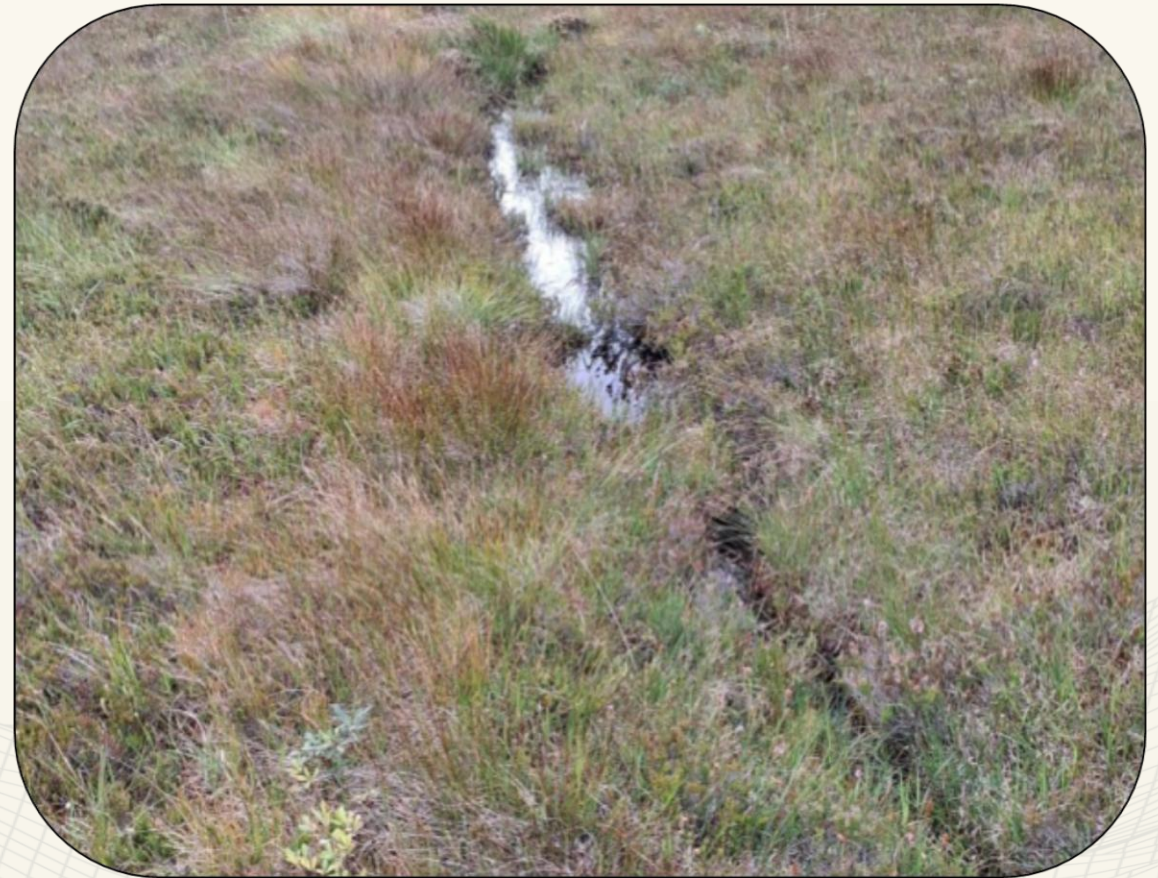
Preparatory drainage

It was common to dig drains on lines that would be cut in the future, in some places the mapped drains are related to the cutting process and are along the toe of a shallow cut bank, where cutting had commenced but has not been extensive.

Dam and reprofile adjacent banks

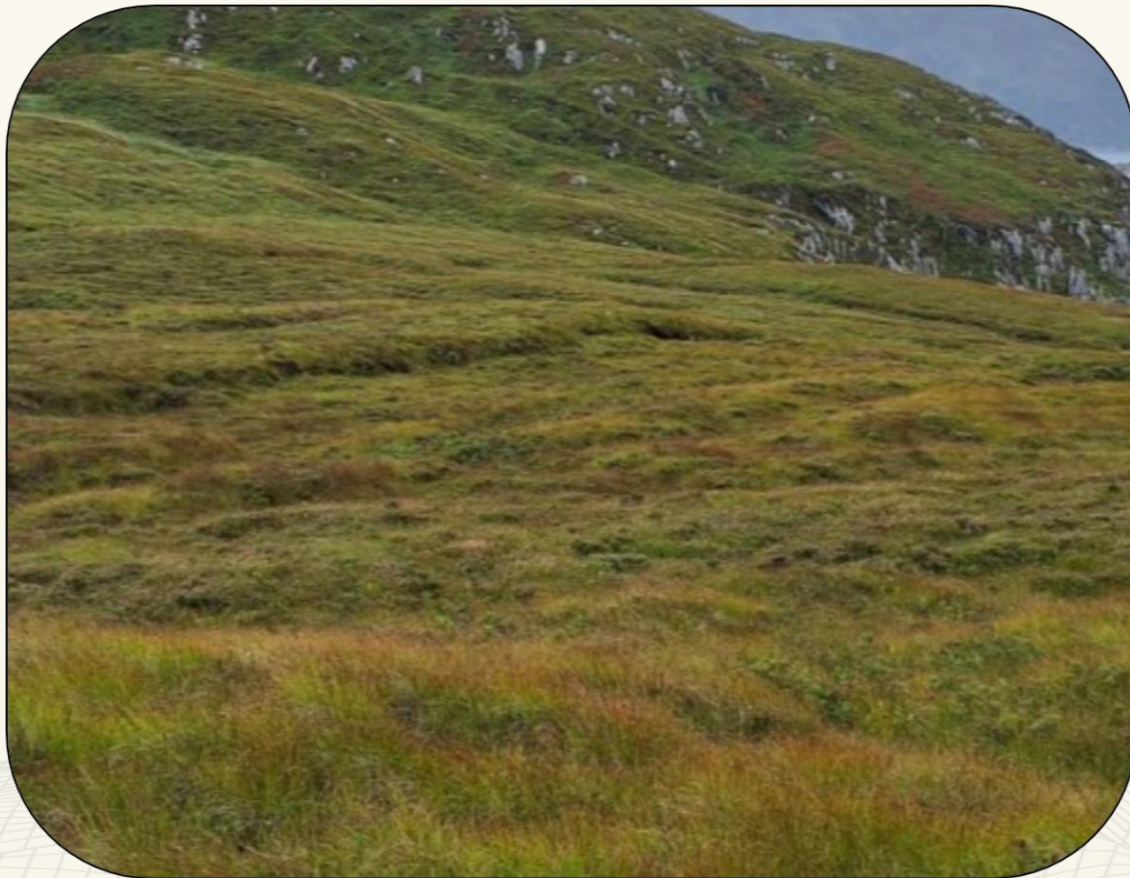
Complex areas of former peat cutting

Some areas have had such extensive cutting that the peat that remains appears to be in narrow ridges between lowered flat zones. Here active edges should be reprofiled and revegetated and oblique or cell bunding should be used to lift the water table in the lowered areas

Adapt wave damming methods to form long low bunds across low zones

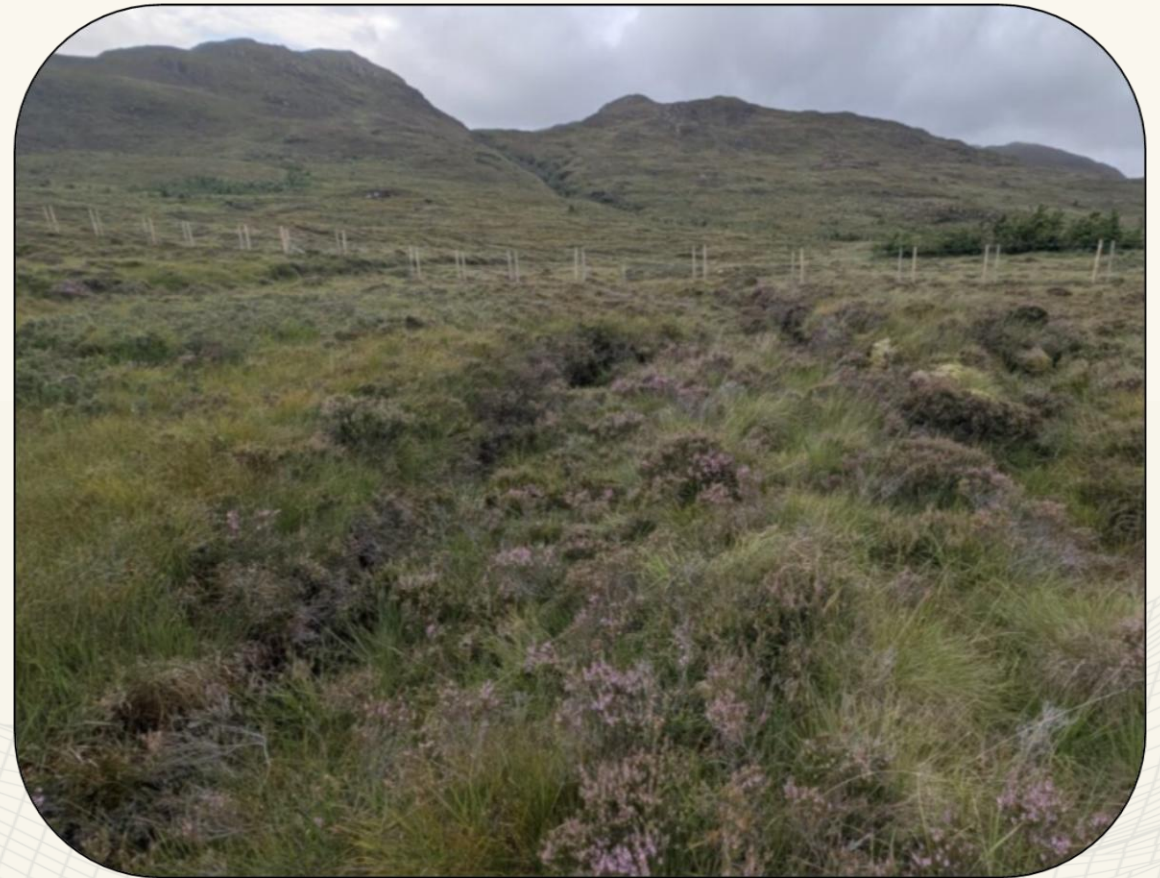
Interspersed cutting and drainage

Some areas are complex with an intimate mix of cutting and drainage. These will be treated using adapted wave damming and zipping techniques to dress edges, block flow and raise water tables.

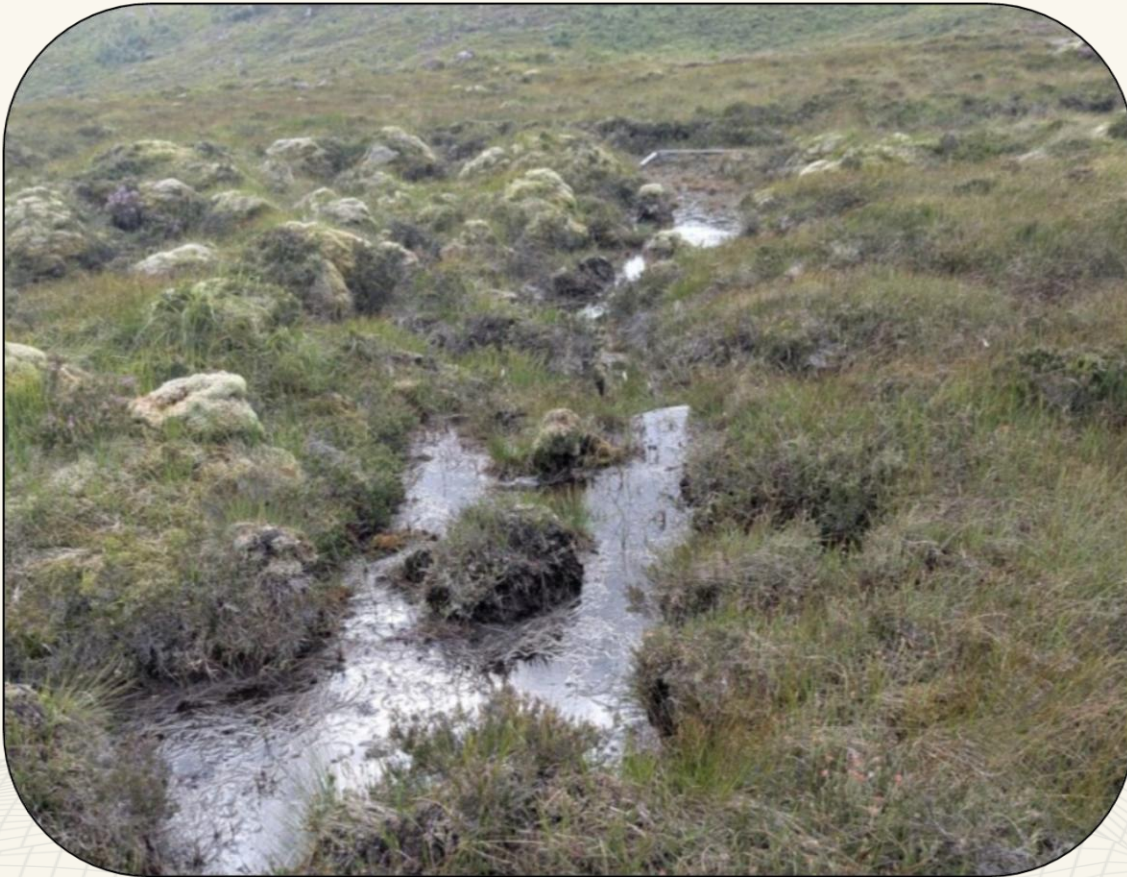
Gully complexes

These are small in scale and relatively rare on most of these sites. The worst features are found in Zone 3. These will be treated using standard reprofiling methods in conjunction with peat and turf dams and micro-turf dams.

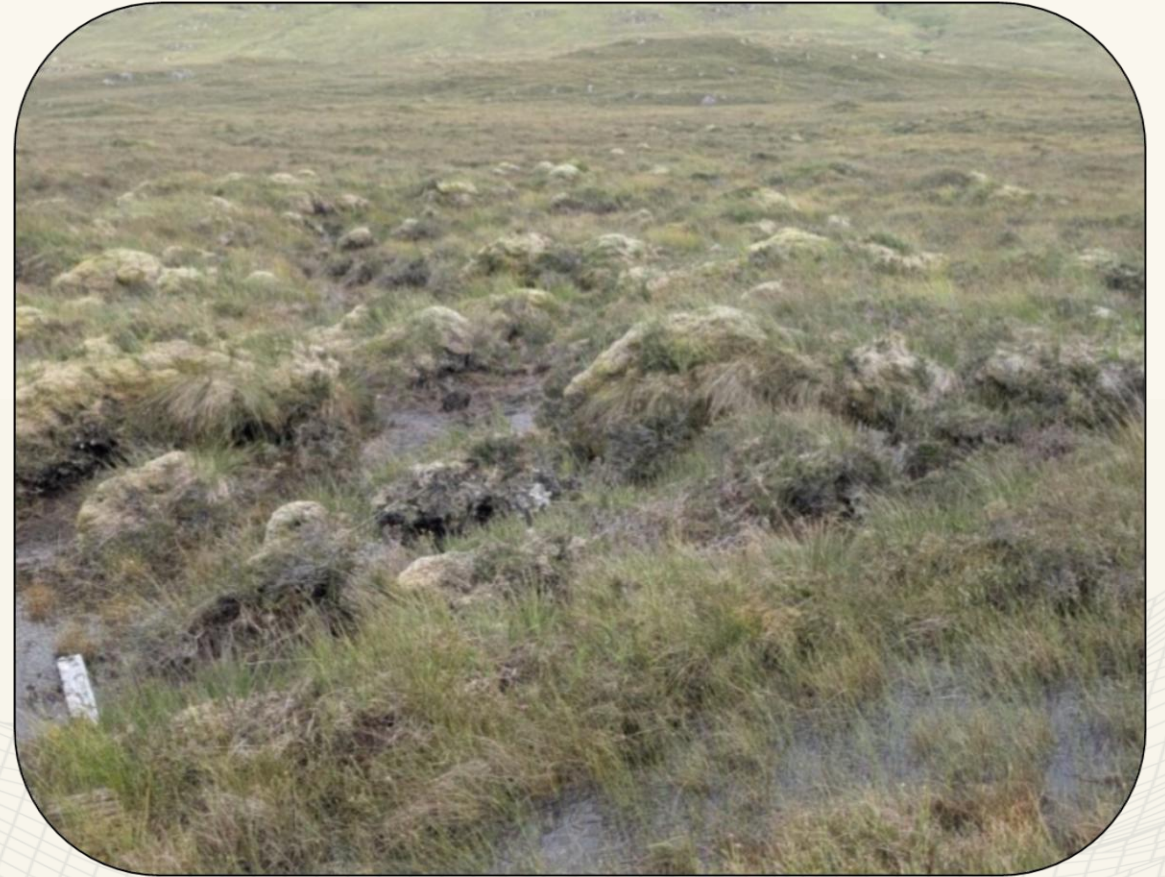
Small gullies and micro erosion

These features will be treated with strategic micro-turf dams and bunds formed using adapted wave damming techniques.

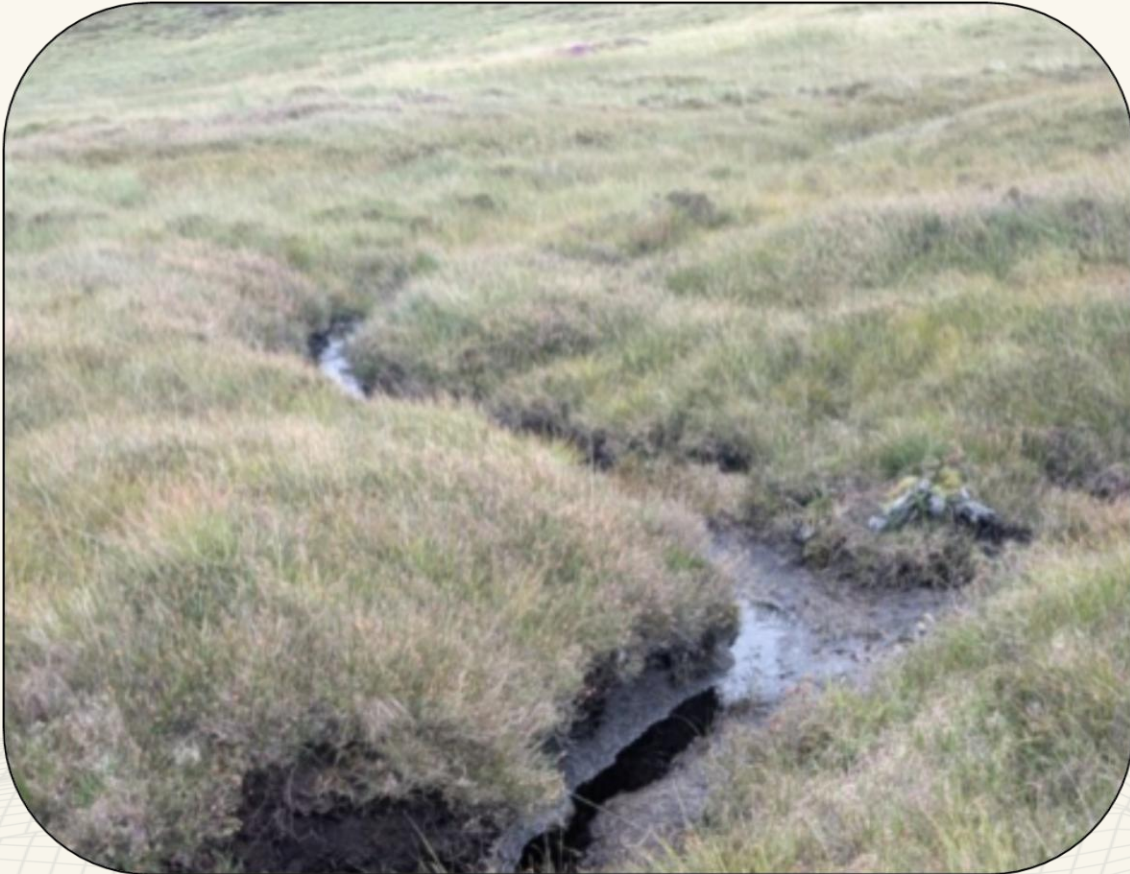
Eroding Pools and areas of active erosion

Small scale erosion features - re profile and re-vegetate using undermine and pack reprofiling method, add turf

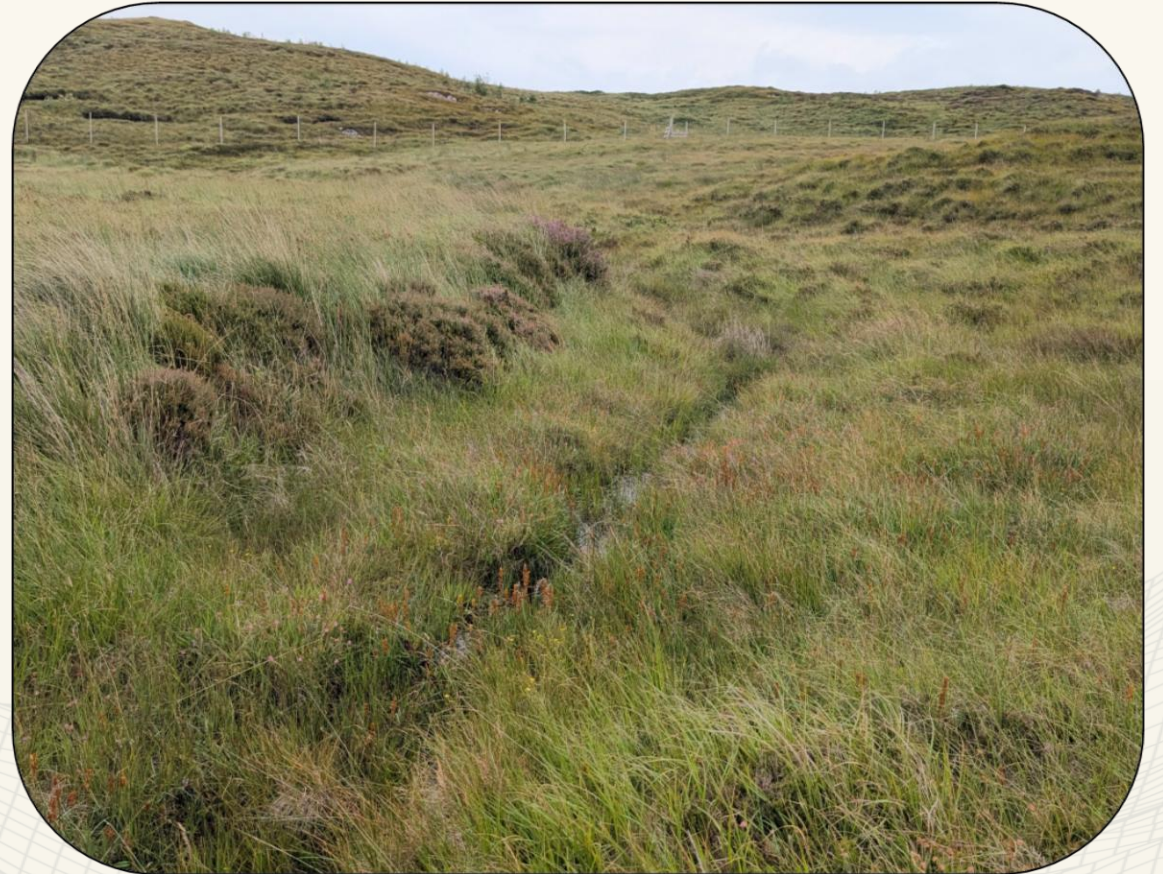
Artificial Drains

Block drains using zippering and wave damming techniques, ensure spoil mounds or lateral bunds adjacent are breached to allow diffuse overland flow

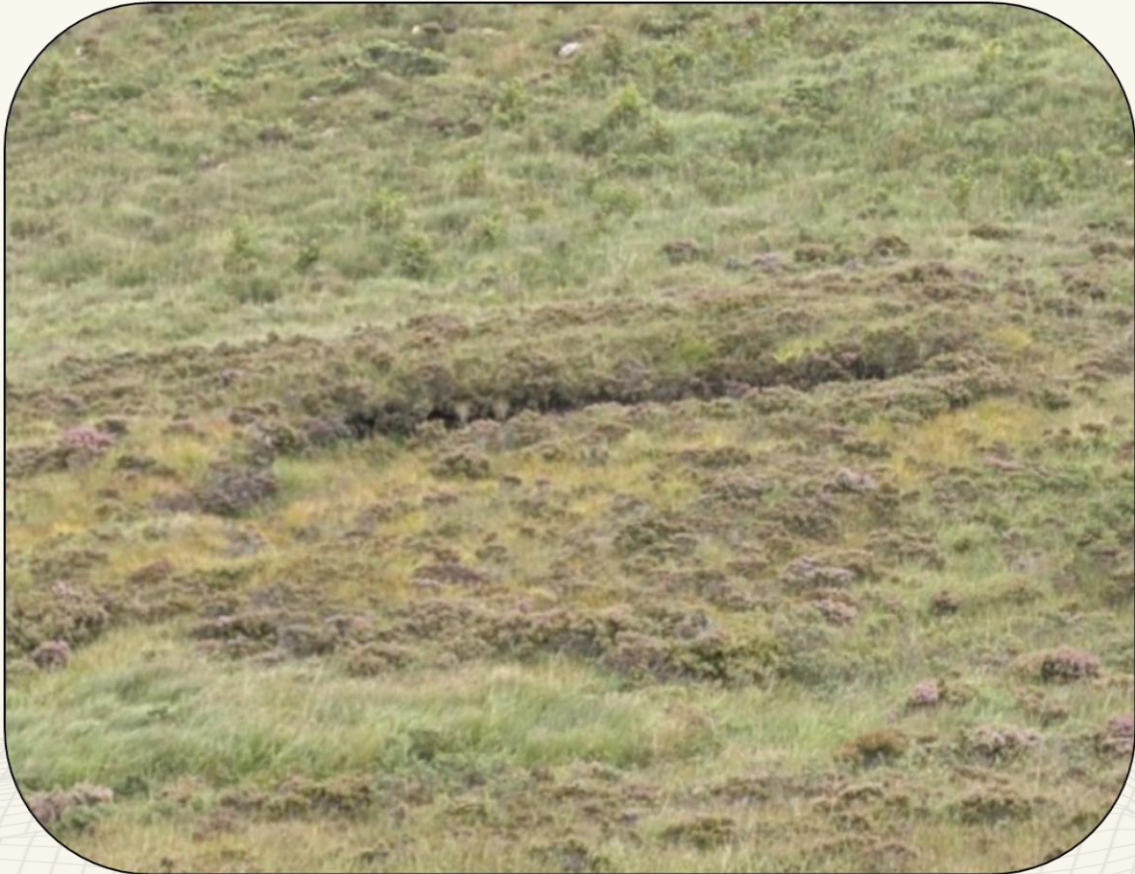
Cut Banks

Former peat cutting banks are common in this area. These have vertical bare faces, obscured by hanging heathy vegetation. The lowered zone at the toe should be oblique or cell banded to reduce the height difference in the water table

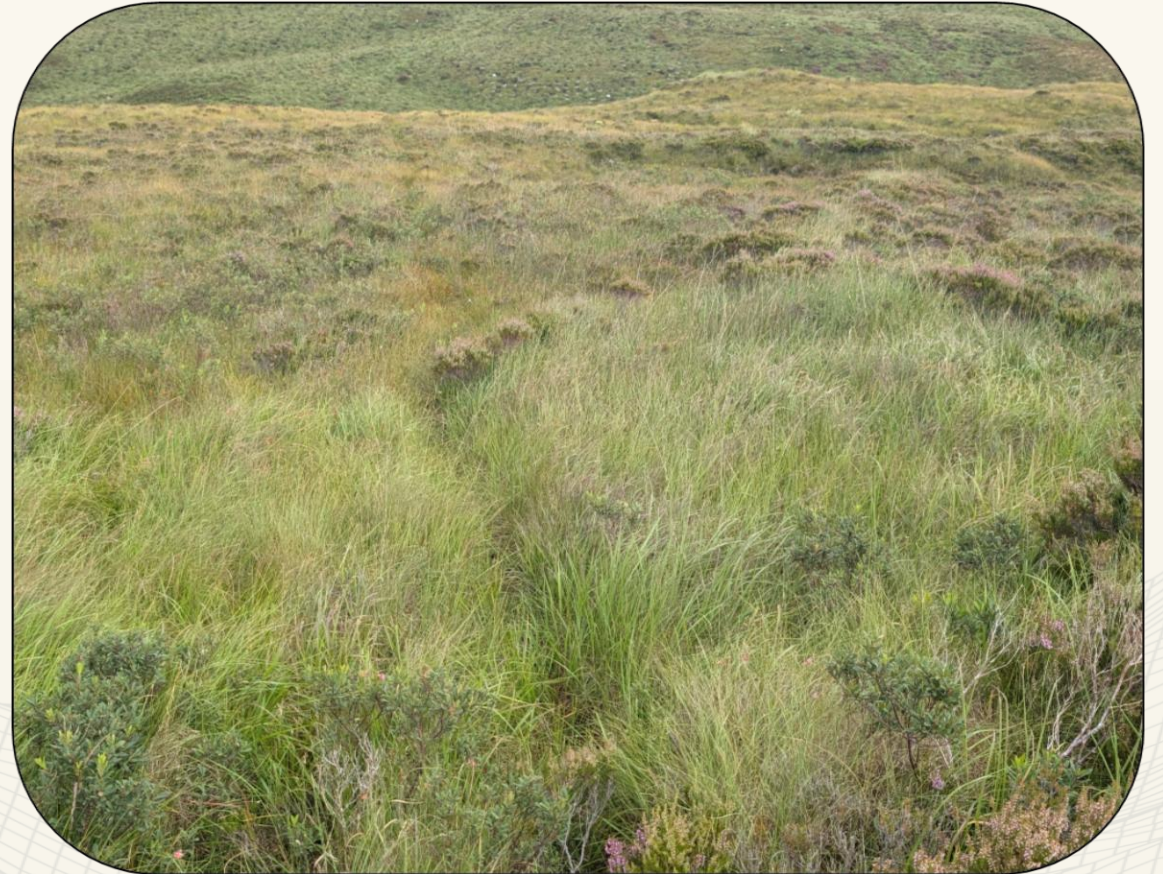
Artificial Drains

Drains vary in function but most warrant some form of intervention. Block drains using zippering and wave damming techniques, or just wave damming where already quite occluded.

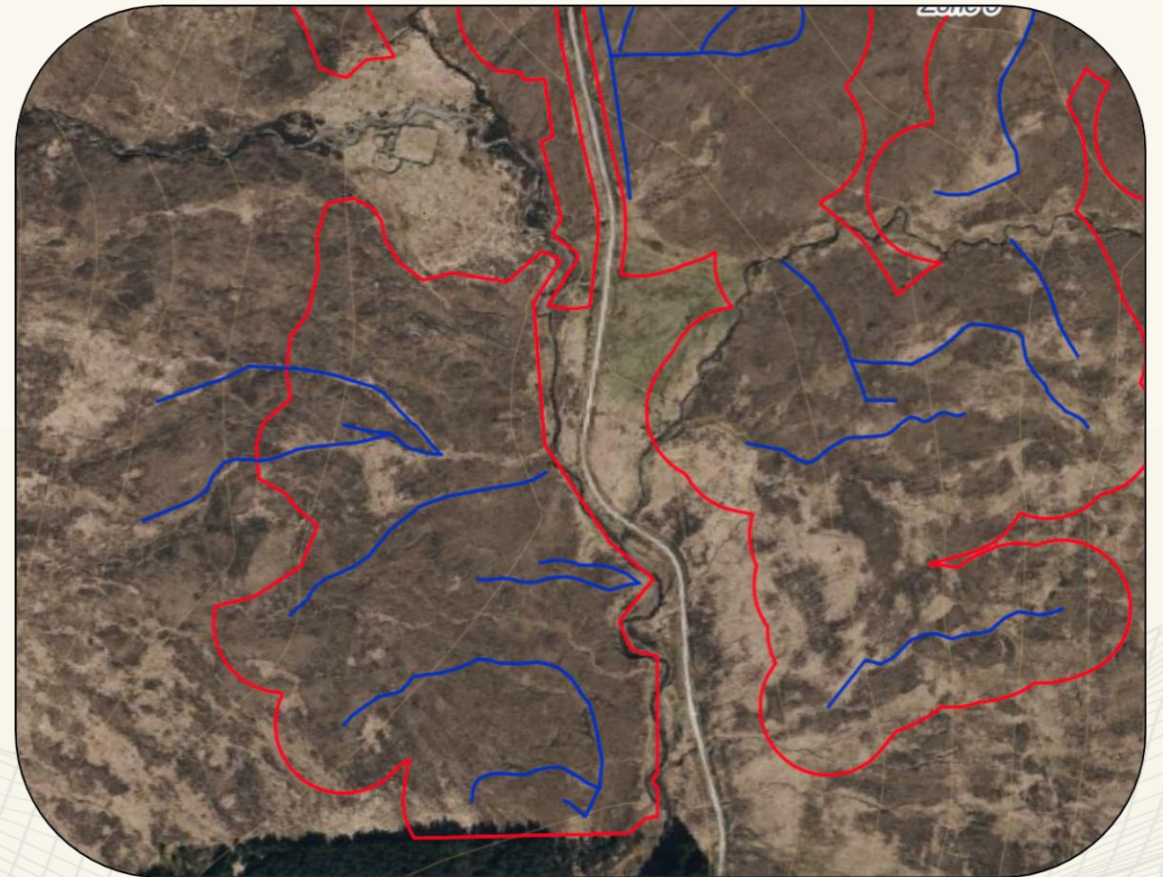
Work Zone 3

This zone has a mixture of drains and cut banks and some erosion features. The work zone is split into several distinct areas either side of the watercourse and road. This zone has the majority of the erosion in this project phase and is the highest work unit, so should be treated earlier in the programme to avoid harsher winter weather.

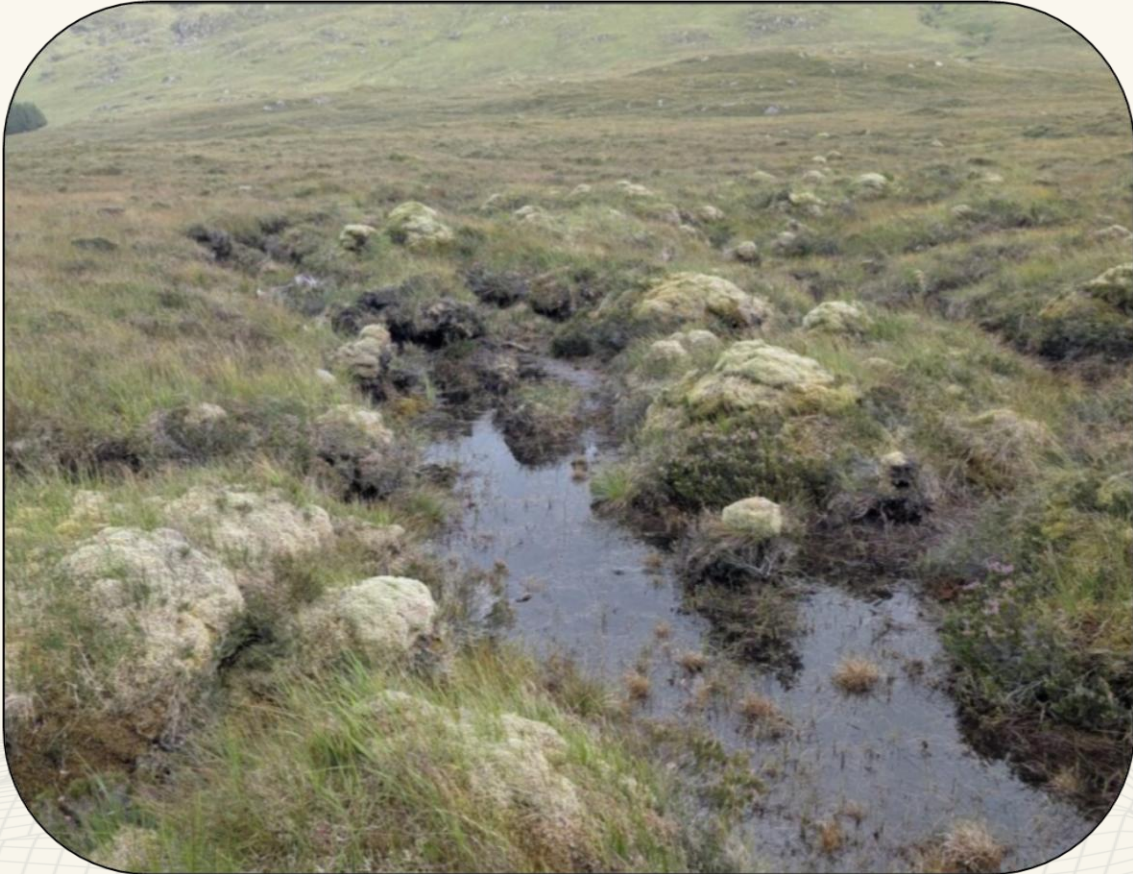
Eroding Pools and areas of active erosion

Treat these features by reprofiling and revegetating. Use undermine or pack reprofiling methods wherever possible. Supplement with targeted peat dams and micro-turf dams in places.

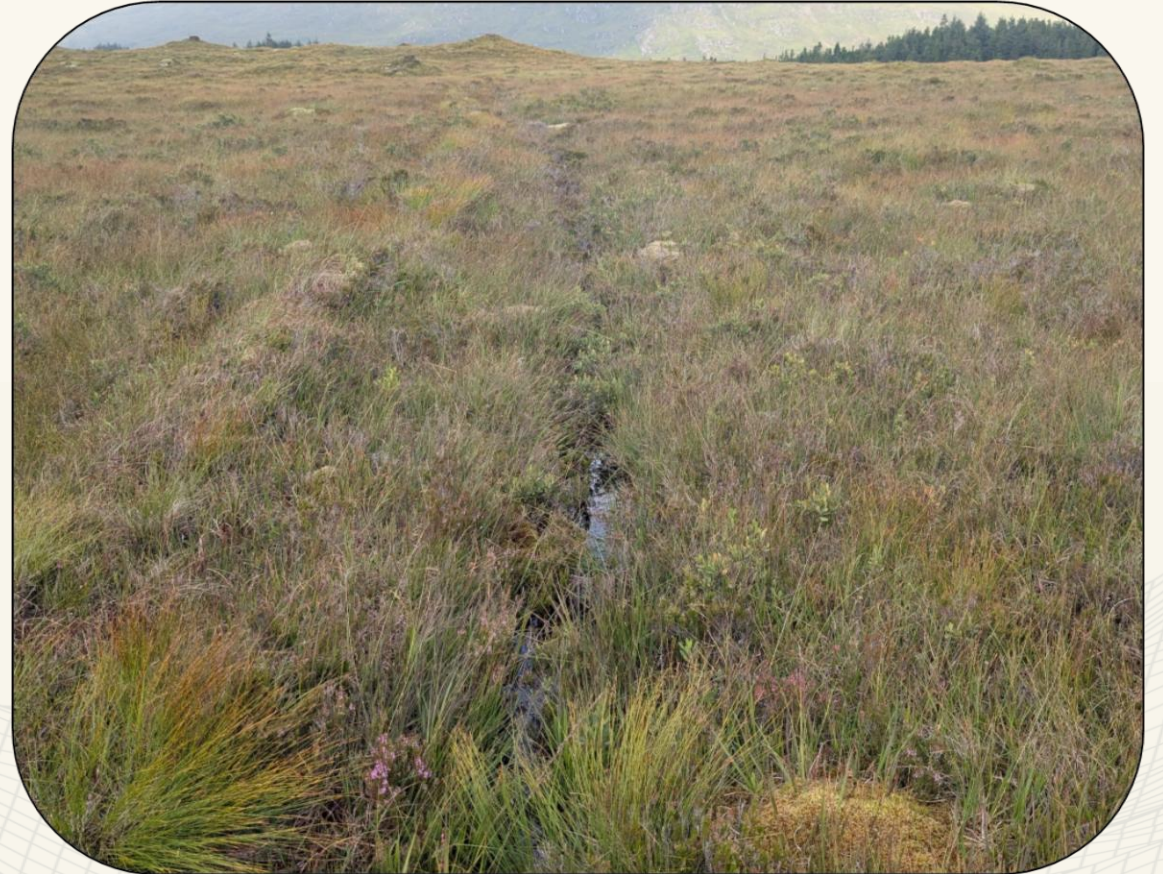
Artificial Drains

Block drains using wave damming and zipping techniques. Lower the relic spoil line as part of this process
